# Manhole Inspection Summary

Manhole # S39W1\_011MH

Insp Date: **11/15/07 2:51 PM**

**Location** Address: **3544 4th St**

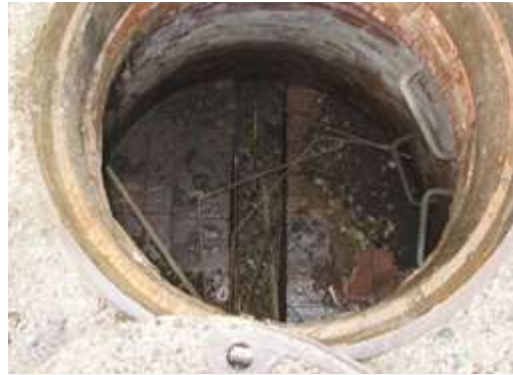
Top View

Comments **Sticks within manhole**

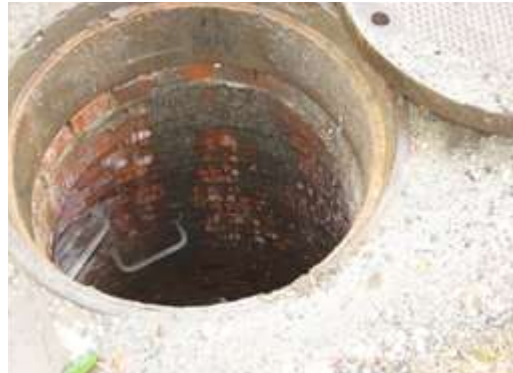
Defect 1

Condition: ☐ Sound ☐ Cracked ☐ Root Intrusion ☒ **Loose Brick** ☒ **Deteriorated**

Infiltration: ☐ None ☐ Joint ☐ Cracks ☒ **Mortar** ☐ Roots ☒ **Wall**

Chimney Infiltration/Discoloration

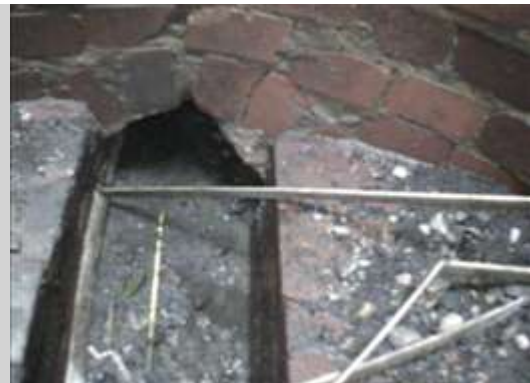
12 O'Clock Outflow

8 in. Circular Gravity Sewer  
Pipe Out @ 12 O'Clock

Deposits: ☐ None ☐ Mud ☐ Sludge ☒ **Debris** ☐ Grease

Infiltration: **None** Pipe Seal Cond: **Cracked**
